Report on the Furs Warehouse Plumbing Failure

Kenneth C. Russell

Department of Metallurgy and Materials Science

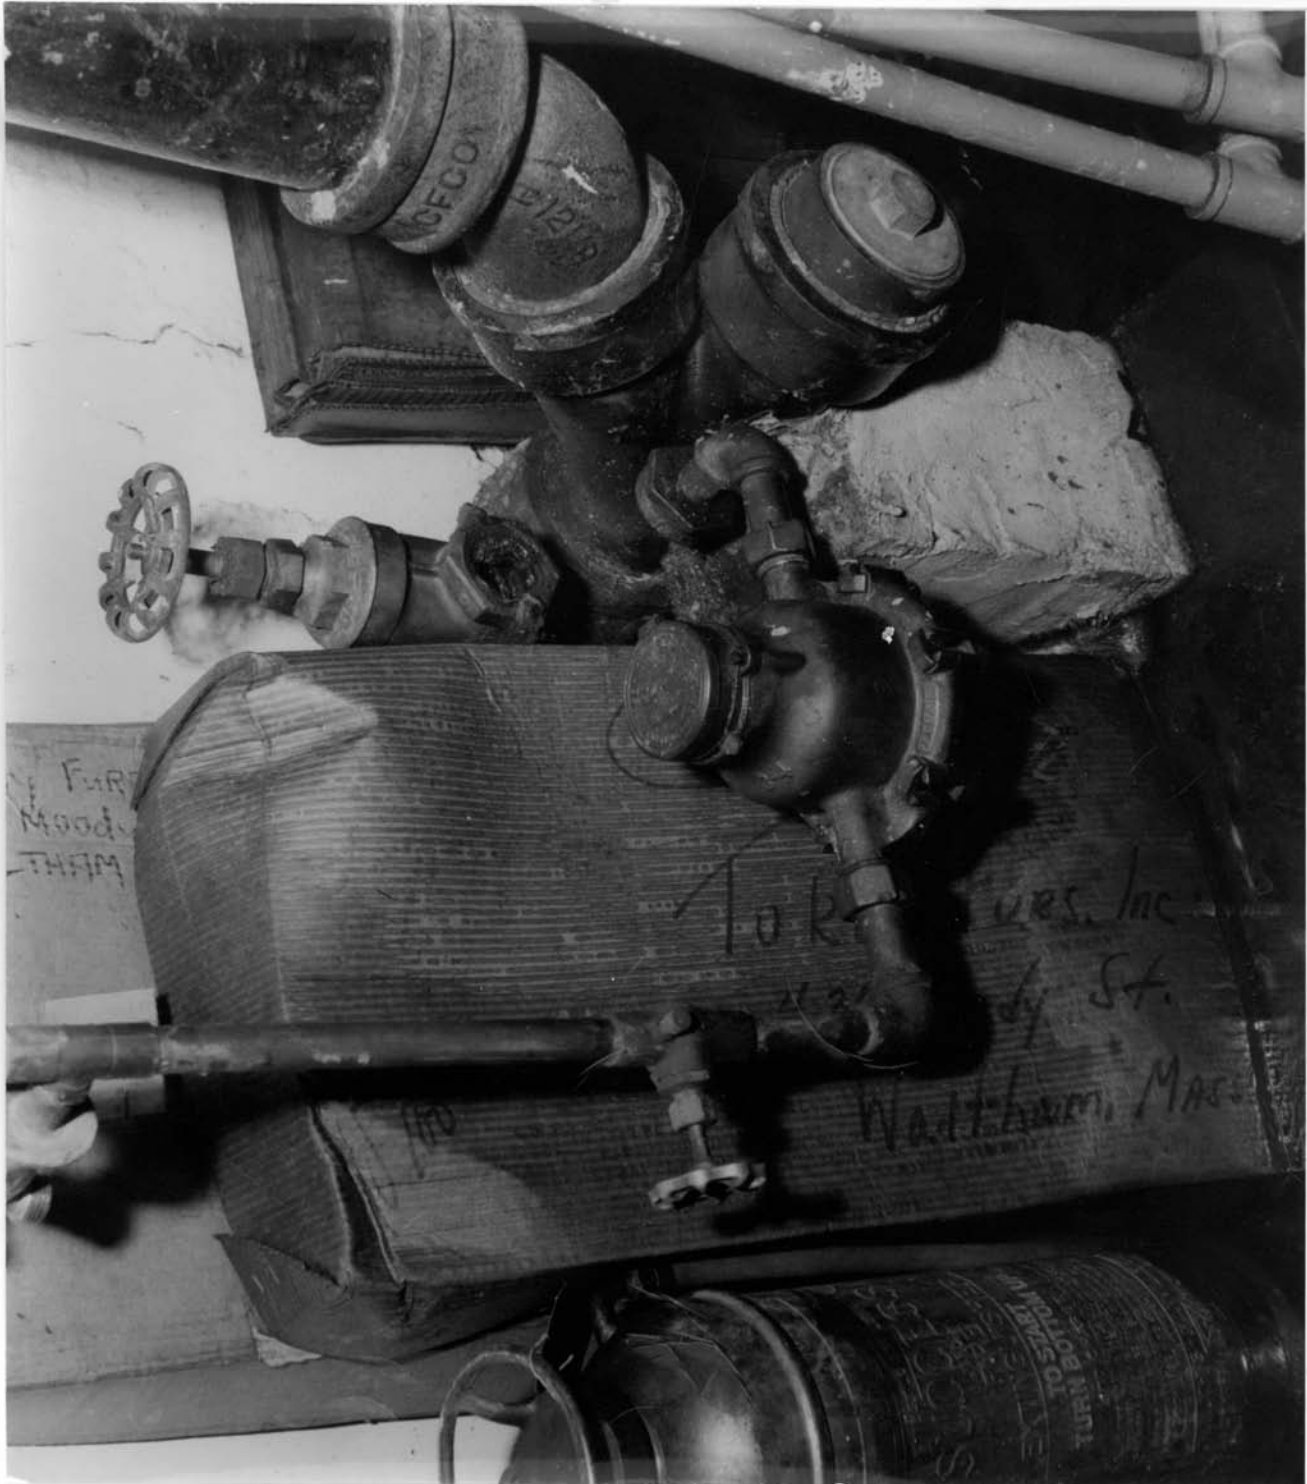
The failure is shown in Fig. 1. The failure took place between the brass valve and a 2" x 3/4" gray cast iron blank bushing. The plumbing carried cold water.

Figure 1: Failed pipe assembly.

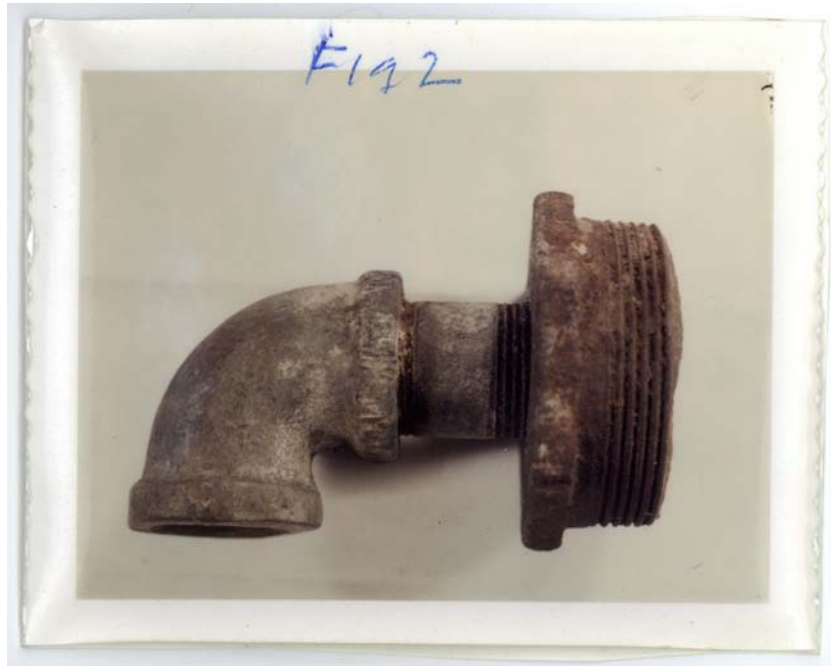
Figure 2: Failed bushing, showing corrosion.

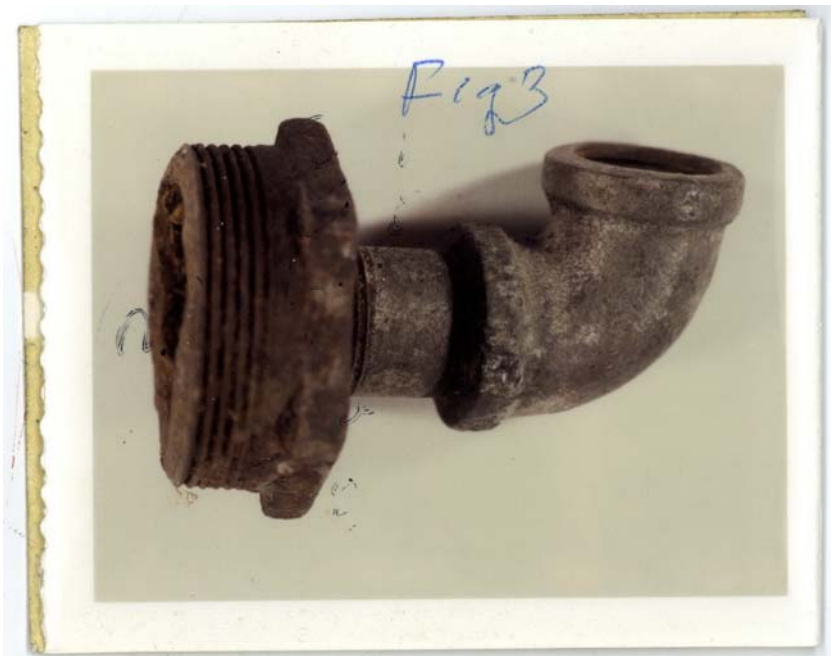
Possibility (5) is straight galvanic corrosion due to connecting the iron bushing to the brass pipe in the presence of water. Examination of the failure indicates extremely even corrosion around the flange circumference, with the 2" flange oxidized to magnetite as shown in Fig. 3. The intense attack that oxidized through to the thread roots next to the brass gate valve is characteristic of galvanic corrosion.

Figure 3: Failed bushing, from the other side.

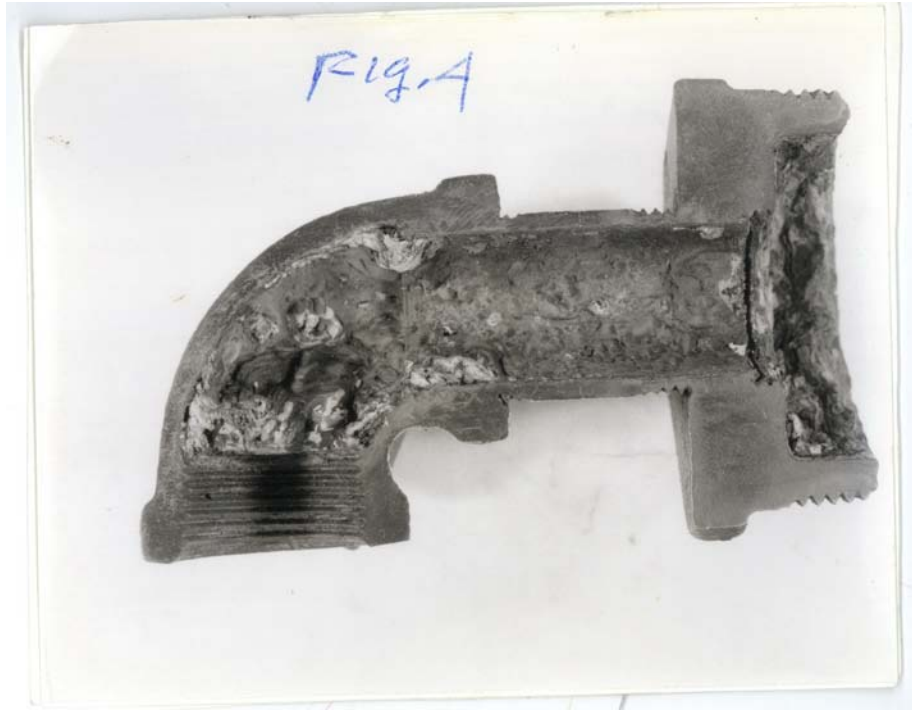
Although some corrosive attack is seen on the nipple and throughout the assembly (Figs. 4 and 5), failure is not imminent other than at the failed location. The corrosion of the nipple is quite possibly also due to the large amount of brass in the system.

Figure 4: Sliced in half, the corroded bushing has been polished and etched.

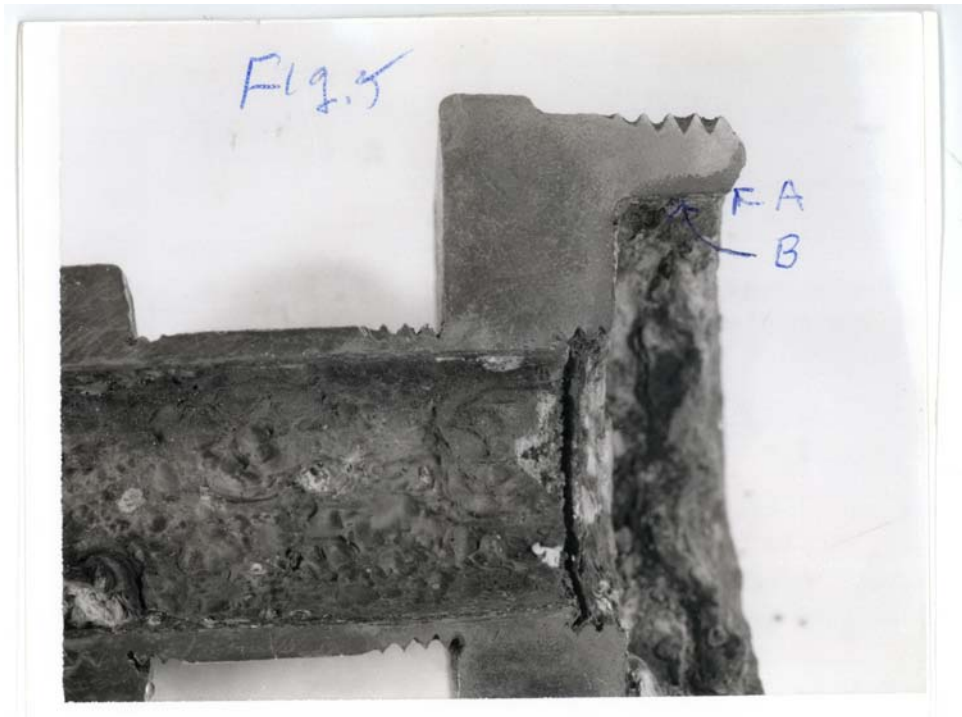
The photomicrograph in Fig. 5 shows a selected area of the polished and etched specimen. The black area penetrating the blank bushing at A is an oxide of iron (magnetite), and this oxide has reached the thread roots on both sides. From Fig. 3, it is apparent that only iron oxide was holding the bushing to the valve at failure. The fracture surface is completely non-metallic.

The corrosion pattern is typical of a galvanic cell. The penetration into the threaded region is seen to be greatest near the brass gate valve and less at greater distance. The relative lack of penetration at the right angle within the bushing may be due to low oxygen supply at that point. The flow of water is relatively small at such locations.

Figure 5: A closeup of the etched metal shows magnetite at the valve.
